EPRI-NASA Cooperative Project on Stress Corrosion Cracking of Zircalloys

NP-717
Research Project 455-1

Final Report, March 1978

EPRI NP-717
Project 455-1
Final Report
March 1978

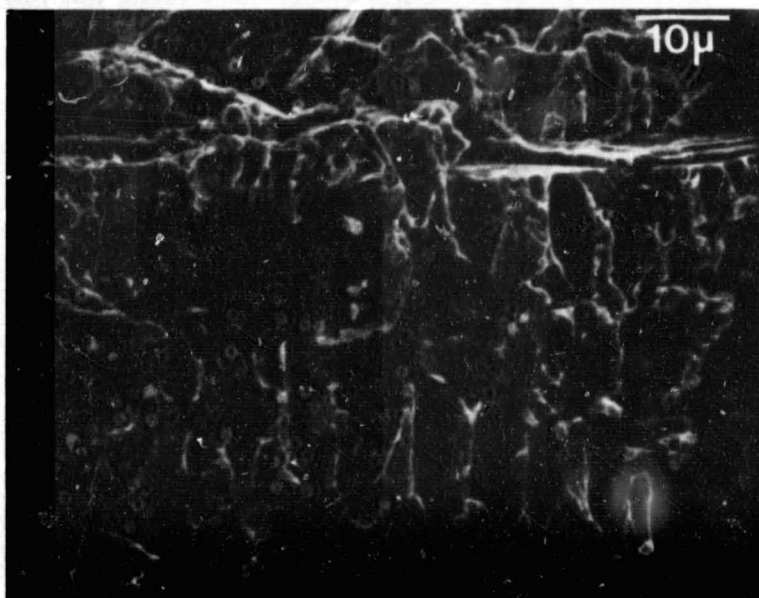
FIGURE 6-23 A TYPICAL FRACTURE SURFACE OF A 4-POINT BEND SPECIMEN OF STRESS RELIEVED ZIRCALOY-4 AFTER FAILURE IN LIQUID CADMIUM AT 633 K

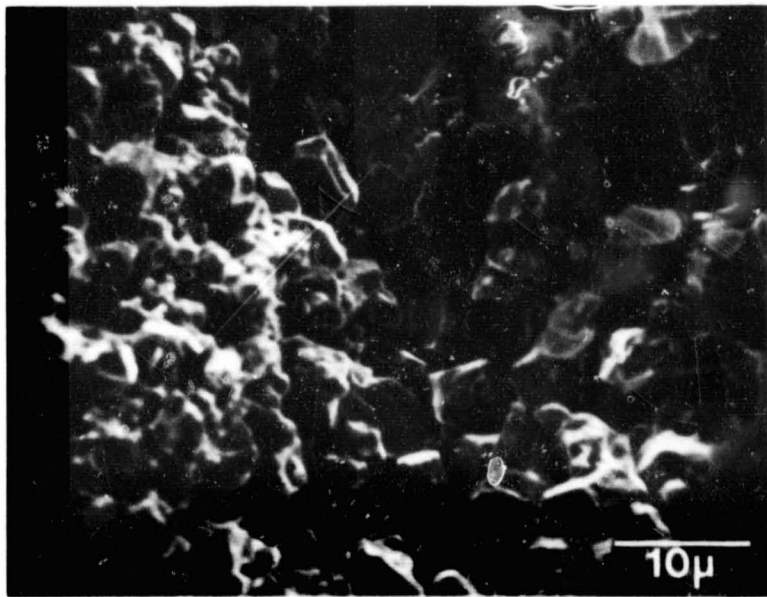
FIGURE 6-24 THE CHARACTERISTIC FLUTED REGIONS AFTER FAILURE IN CADMIUM AT 633 K

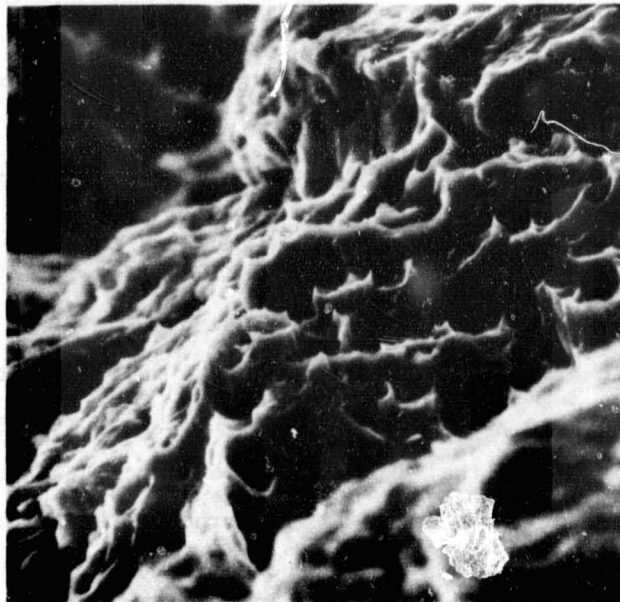
Two of the ring samples from one batch were studied in detail. One sample (N-1) did not have a visible crack; the other (N-3) had a hairline crack extending longitudinally from the root of the notch about halfway along the length. Sample N-1 (uncracked) was broken so that a longitudinal crack was formed extending the notch the entire length of the ring. The fractured surface of the ring was examined in the SEM. Most of the fracture surface showed features typical of ductile tearing, as seen in Figure B-2. However, scattered in the dimpled regions there were areas of flat cleavage, as shown in Figure B-3. The cleavage areas covered about a tenth of the total fracture surface. Analysis of the cleaved regions showed the presence of a few percent iron and iodine or tin and iodine. Cleaved regions were observed in the middle of the tubing wall with no obvious access to the surface of the metal and yet iodine and iron were present and presumably involved in the cleavage.

FIGURE B-2 SEM PHOTOGRAPH OF THE DIMPLED FRACTURE SURFACE OF RING SAMPLE N-1 (5000X)

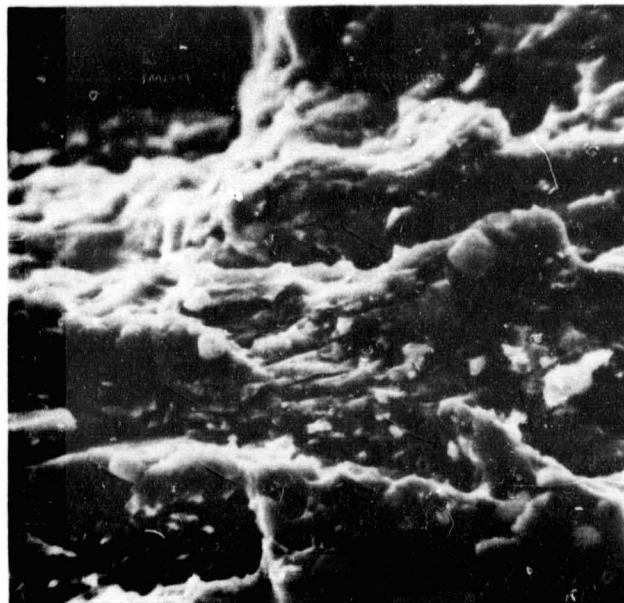
Analysis showed no Fe and a trace of I.

FIGURE B-3 SEM PHOTOGRAPH OF CLEAVAGE FEATURES OCCASIONALLY PRESENT ON FRACTURE SURFACE OF SAMPLE N-1 (2000X)

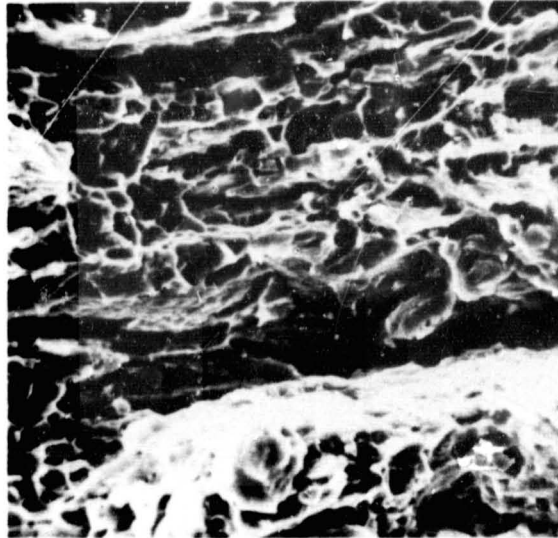
Sample N-3 was broken mechanically so that the hairline crack was extended longitudinally, and the resultant fracture surface was examined in the SEM. The fracture surfaces showed a combination of ductile dimples and cleavage as illustrated in Figure B-4. The area fraction of ductile fracture increased with distance along the crack from the root of the notch to the mechanically broken region. However, even in the region broken after the test, about half the fracture area consisted of cleavage. Analysis of the dimpled areas showed almost pure Zr with some Fe. The cleaved areas were rich in Fe, in some cases to the extent that Zr could not be detected.

Analysis of the center region showed a few percent of Fe and I.

FIGURE B-4 SEM PHOTOGRAPH OF THE FRACTURE SURFACE OF SAMPLE N-3 (2000X)

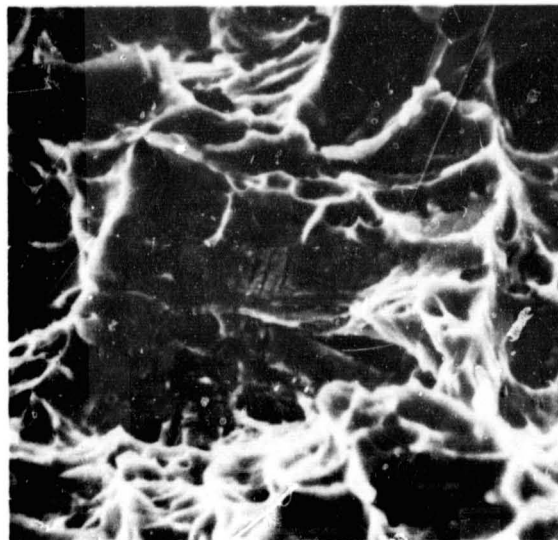
Analysis of the flat regions just below the center of the photo showed all Fe with a trace of Al (no Zr). The dimpled regions showed Zr with a few percent Fe.

FIGURE B-5 SEM PHOTOGRAPH OF FEATURE FOUND IN FRACTURE SURFACE OF AS-RECEIVED ZIRCALOY-4 TUBING (2000X)

processes. Occasionally a feature like the one in Figure B-5 was observed. Analysis of such features showed only Zr.
